redeswood

Tree Inspection Report

Wall Parish Council

Village Centre and St Oswalds in Lee Church Yard

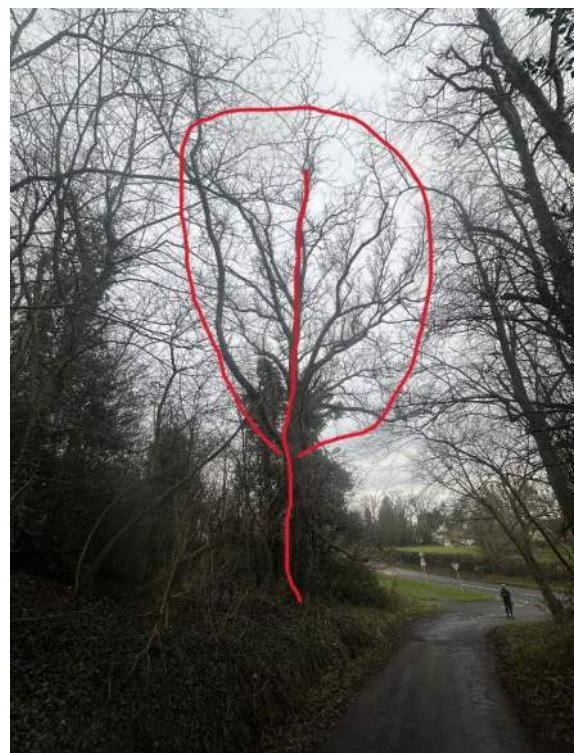
Photograph 4 – Ash tree in G2, on roadside

- T906 (Beech) – canopy reduction
- T907 (Rowan) - epicormic growth removal
- T911 (Ash) - Dead wood removed
- G1 – Ash trees with ADB to be removed, as shown in the photos attached at appendix 3.
- G2 – Ash tree with ADB to be removed, before the canopy gets to more than 50% die back, and the tree becomes too brittle to climb.
